Case Study: A PFAS Investigation and Remediation at a Massachusetts Medical Device Coating Operation

MCTA Annual Meeting Sturbridge, MA November 7, 2024

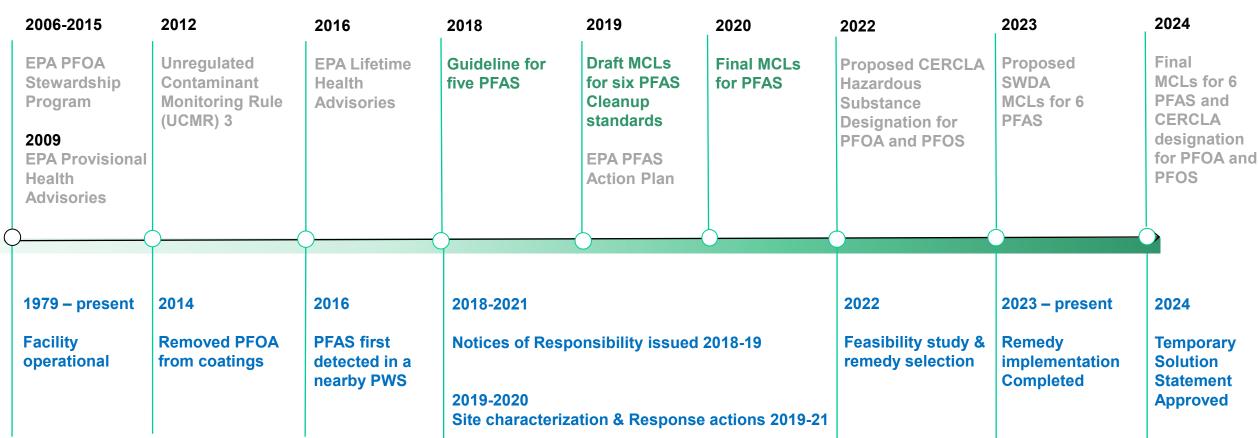
Case Study: Facility Investigation and Regulatory Timeline

PFAS testing in public drinking wells started in 2013 and intensified in 2016 kicking off investigation
